Residential Inspection Report To NZS4306

Prepared exclusively for:
Mr Customer

XYZ St, Auckland

Prepared by:
Right Home NZ Limited
76B Rathmar Drive, The Gardens , Auckland,
0800 2R8HOME support@righthomenz.co.nz

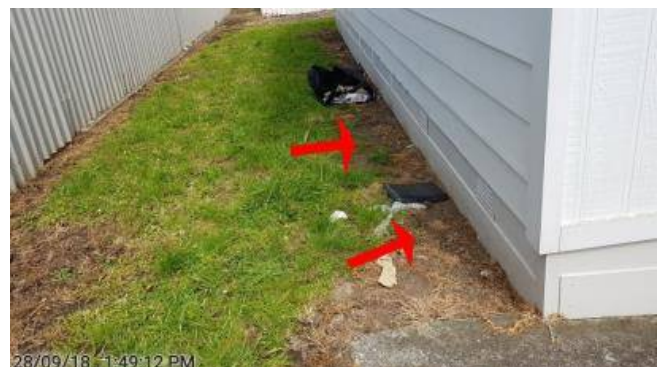
2.4 SURFACE WATER CONTROL

The ground is sloping towards the house (negative drainage) at rear. The ground should slope away from the home foundation. Excessive moisture content in soil supporting the foundation can compromise foundation integrity.

The Inspector recommends re-grading these areas to improve drainage near the foundation.

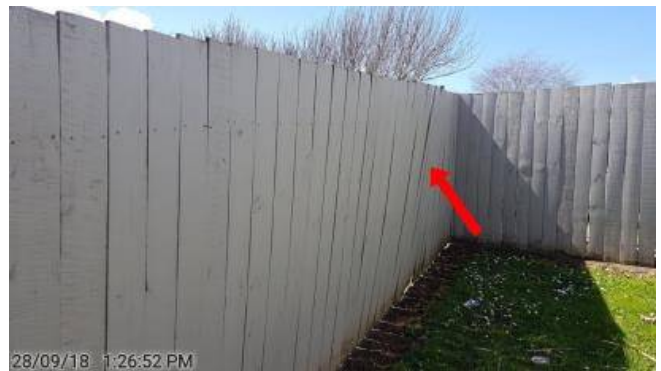
Fencing is leaning at left side. Recommend this be repaired by a qualified fencing contractor.

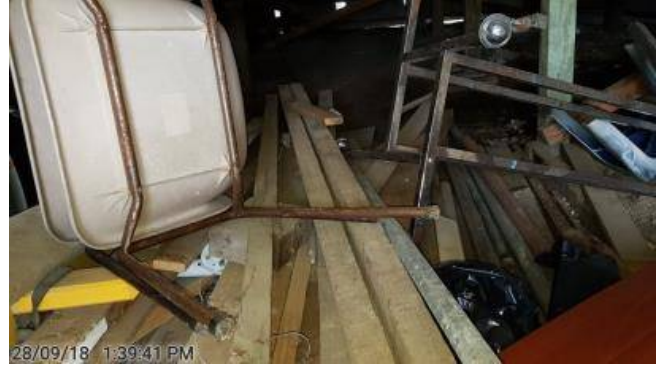
3.3 LIMITATIONS

Items stored limited the movement in the subfloor. Recommend to remove them for better ventilation.

Items stored limited the movement in the subfloor.
Recommend to remove them for better ventilation.

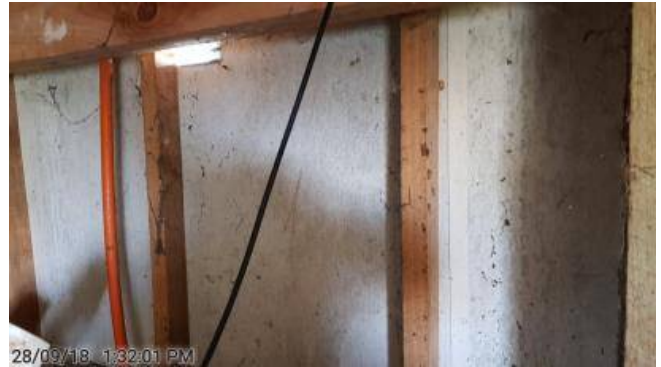
3.7 Fibre Cement Wall

The fibre cement baseboards covering the sub-floor may contain Asbestos considering the age of the building. Recommend to get this tested.

Overview.
The fibre cement baseboards covering the sub-floor may contain Asbestos considering the age of the building. Recommend to get this tested.

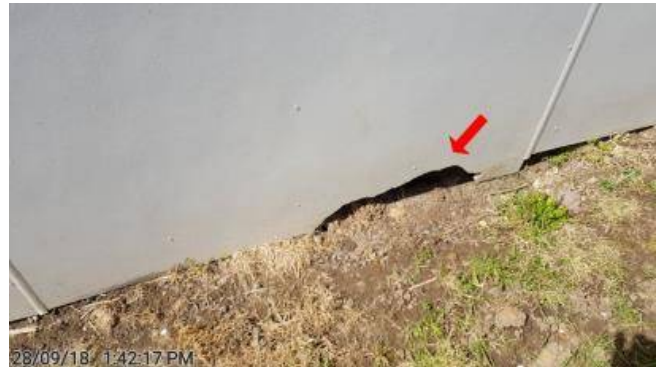
There are damages to the fibre cement base boards covering the subfloor space. Recommend this be corrected by a qualified contractor.

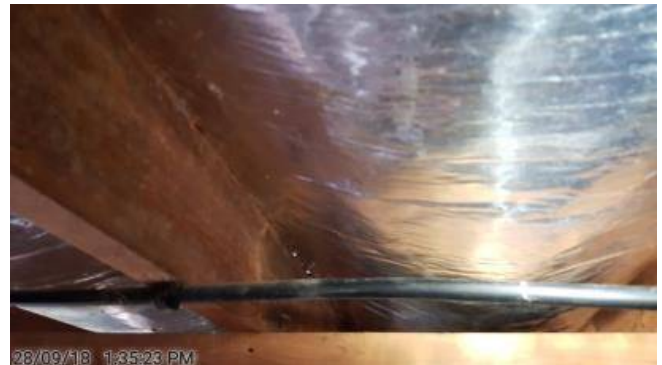
3.14 INSULATION TYPE

The floors above the crawlspace has FOIL INSULATION. This insulation is not permitted now a days. This has potential electrical safety hazards. Recommend to consult a registered electrician to mitigate the risk.

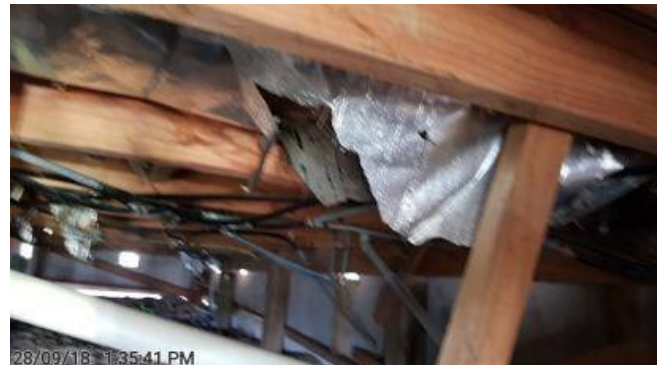
3.15 INSULATION CONDITION

Insulation is damaged in many places. Recommend this be corrected.

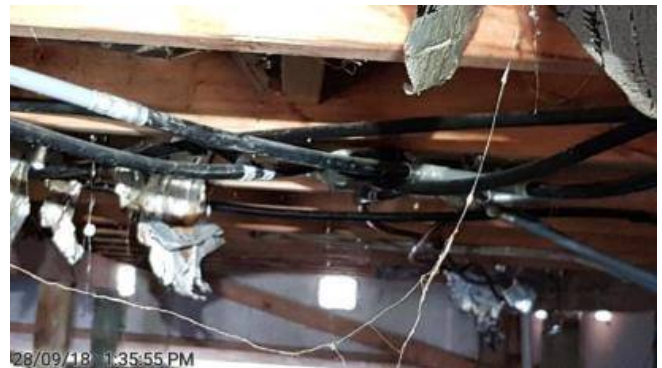
3.18 WATER SUPPLY PIPES

Black plastic piping found in the subfloor. This type of black plastic pipe has known history of causing water leaks at joints. In some places it has been replaced which appear to be done as a result of leak. Recommend this be evaluated by a registered plumber.

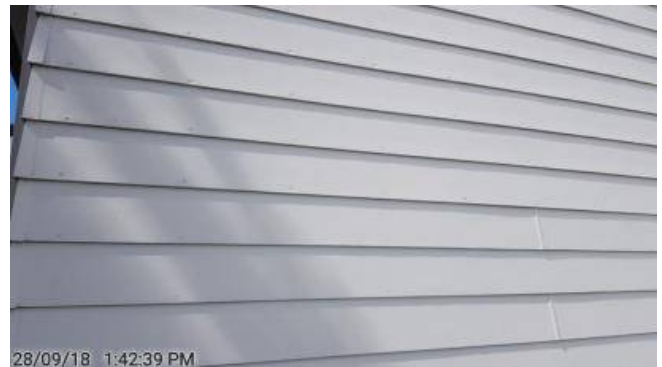
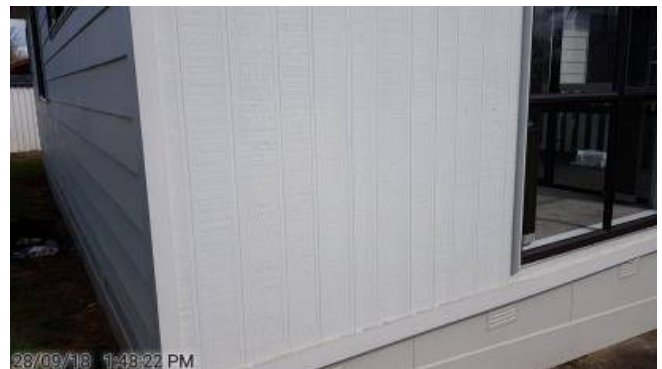
4.3 CLADDING MATERIAL

The exterior wall cladding is Fibre Cement plank weatherboard. This may contain Asbestos considering the age of the building. Recommend to get this tested for Asbestos. They should be kept painted for protection.

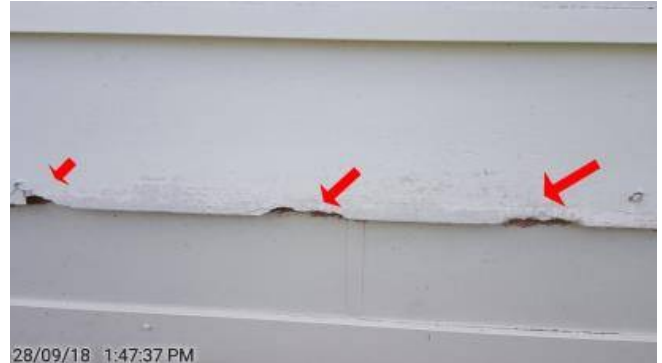
4.4 CLADDING CONDITION

Bottom edges of some cladding planks are weathered. Recommend these be repaired / replaced to avoid further damage.

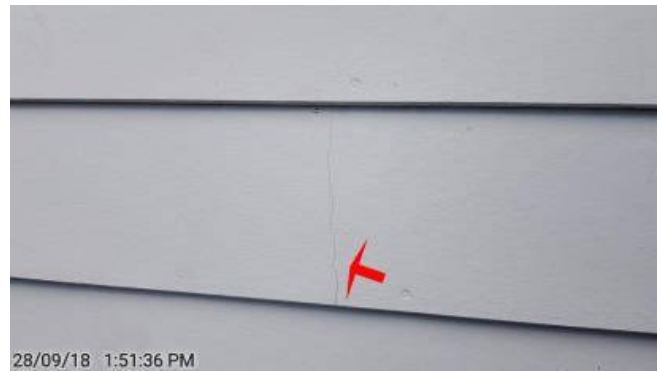
A crack on the left wall be repaired to avoid moisture intrusion.

A crack on the left wall will be repaired to avoid moisture intrusion.

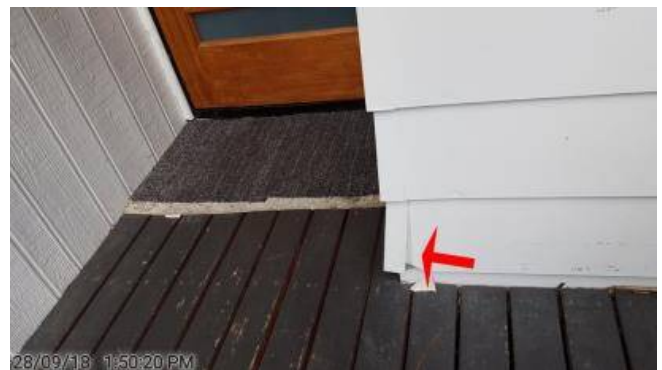
4.5 TRIM / FLASHING

Corner trim near the front door is displaced. Recommend this be corrected.

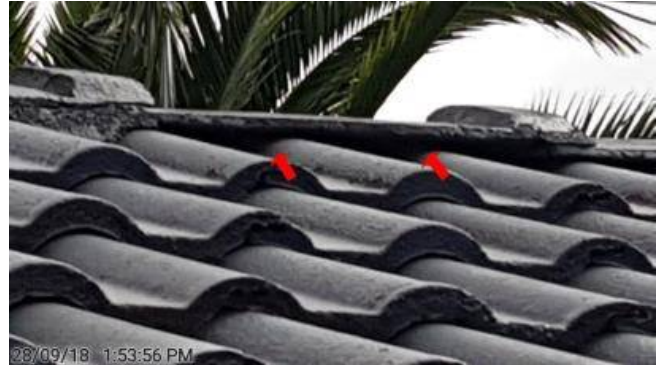
5.3 CONCRETE TILES

Mortar missing on some ridge tiles. Recommend this be repaired to prevent damage to the underlying roof structure from moisture intrusion.

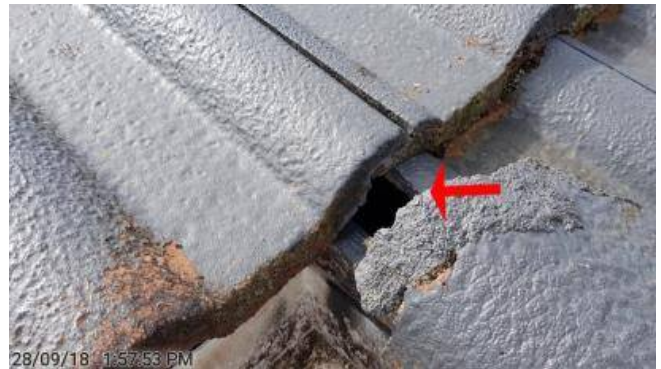
A tile was dislocated at the right side above the door leaving a gap. This can cause roof leak. Recommend this be repaired by a qualified roofing contractor.

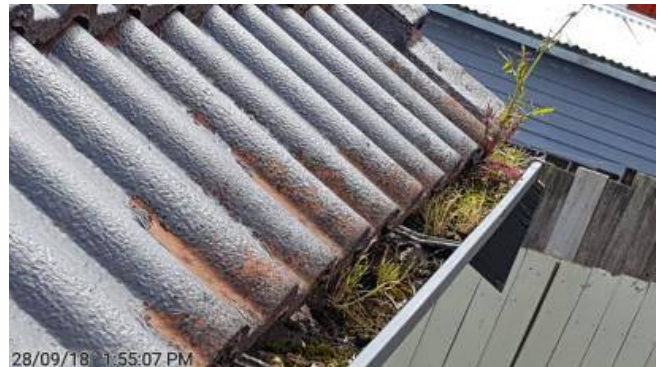
5.4 GUTTERS

Remove debris from gutter to allow proper roof run-off. Recommend installing screens over gutters to prevent further accumulation of debris.

Debris visible in the gutters at the time of the inspection.
Remove debris from gutter to allow proper roof run-off. Recommend installing screens over gutters to prevent further accumulation of debris.

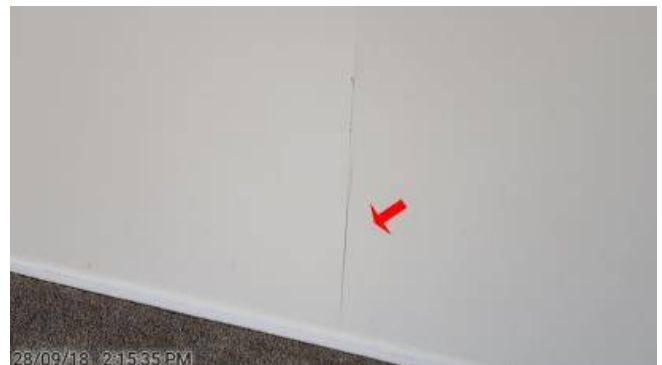
8.3 WALLS

Joint cracking visible in general. Recommend to patch and paint. Recommend this be monitored.

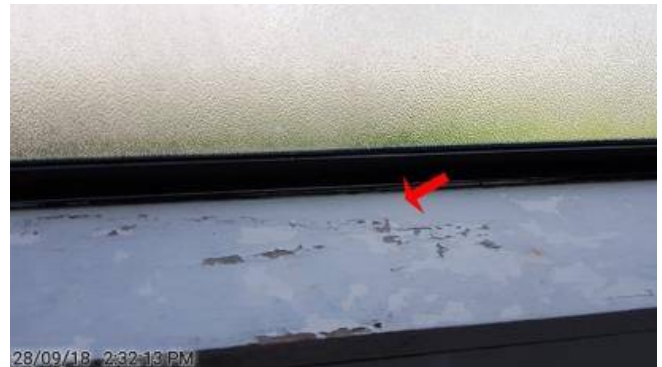
8.14 WINDOWS

A window sash in this room exhibited minor deterioration. Recommend this be painted.

A window sash in this room exhibited minor
deterioration. Recommend this be painted.

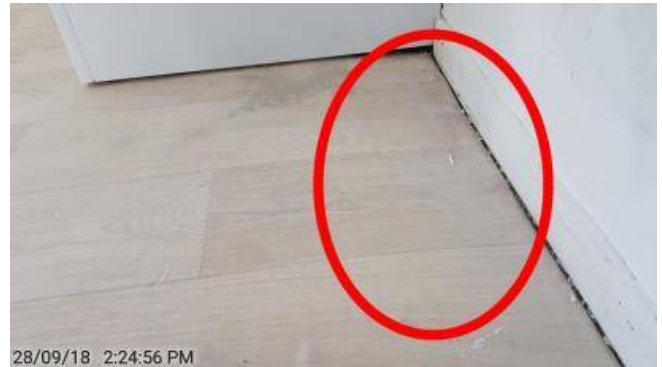
8.18 FLOORS

The floor appeared depressed close to the wall which appeared to be caused by previous water damage. Recommend this be further investigate using invasive / destructive inspection techniques by a qualified weather tightness surveyor to assess the damage to the floor and wall and repairs undertaken.

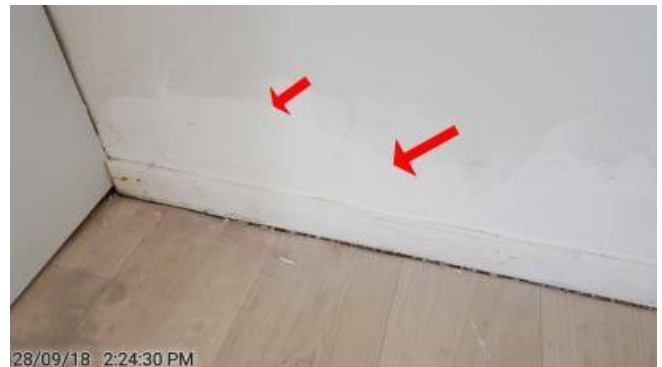
8.19 WALLS

The wall is repaired poorly around this area. Recommend this be further evaluated and repaired by a qualified builder.

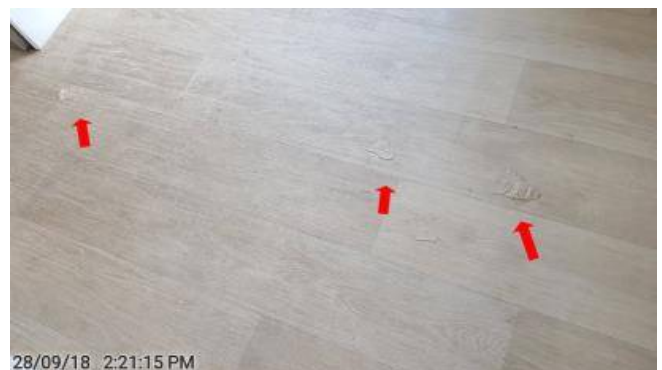
8.26 FLOORS

Damage to the vinyl flooring noticed. Recommend this be repaired.

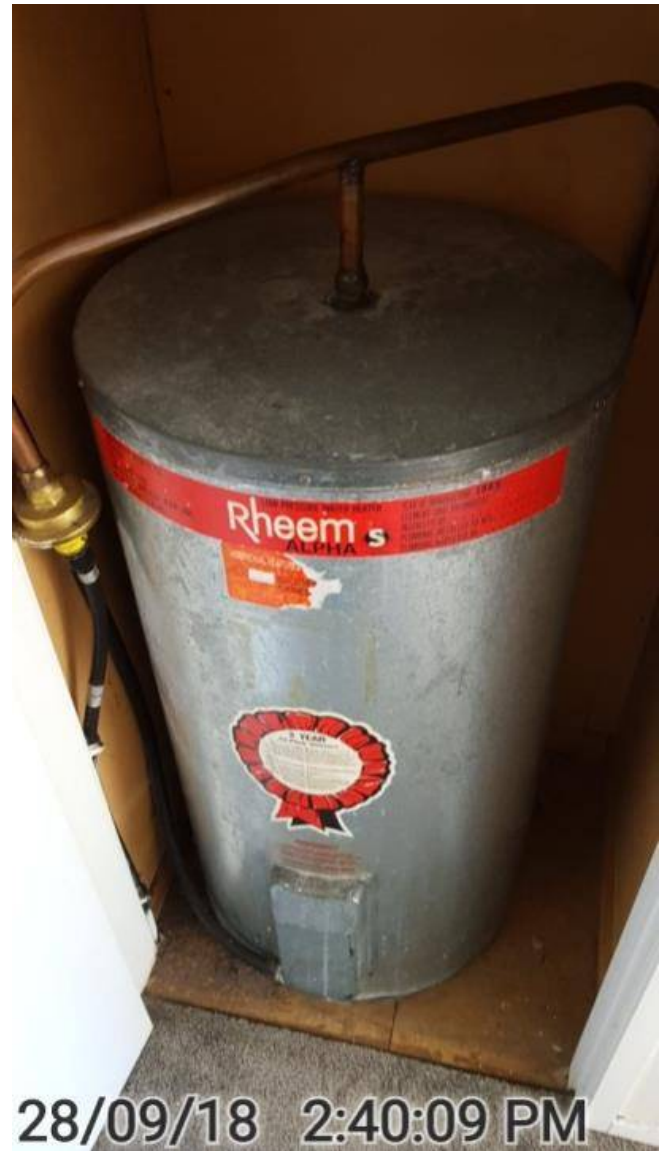
9.8 Exposed Water Heater Condition:

Seismic restraints not installed. To ensure the stability during earthquake, it is recommended to install seismic restraints by a plumbing contractor.

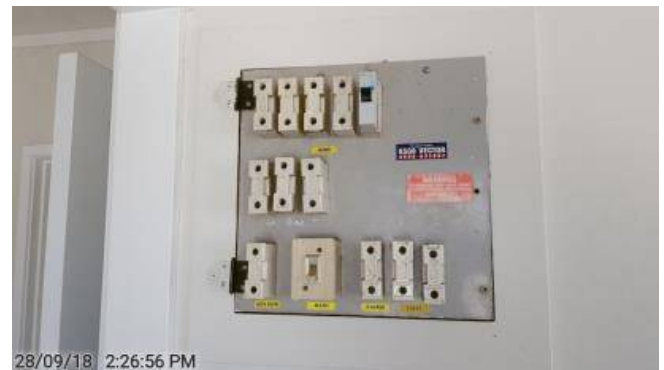
10.1 Main Panel Devices:

Service panels of this type and age were not designed to handle the larger loads placed upon service panel equipment by electrical appliances commonly found in modern homes. The Inspector recommends evaluation by a registered electrical contractor to determine the current condition and upgrade options.

The main electrical service panel appeared to be original and was of old fuse type. Service panels of this type and age were not designed to handle the larger loads placed upon service panel equipment by electrical appliances commonly found in modern homes. The Inspector recommends evaluation by a registered electrical contractor to determine the current condition and upgrade options.

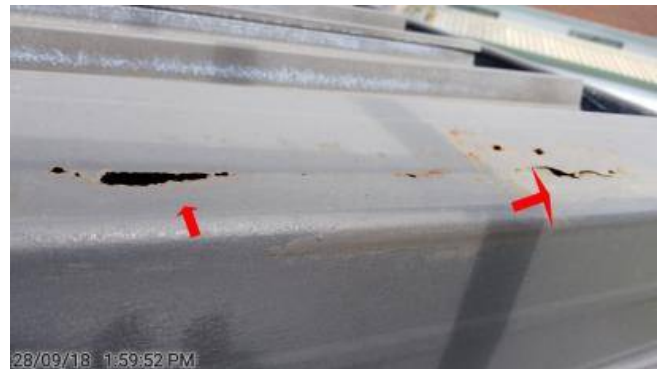
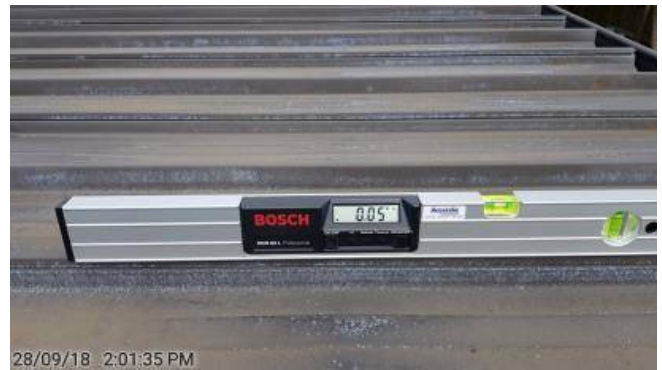
Rust damage with holes on the roof sheet noticed which can cause roof leaks. Recommend this be repaired by a qualified roofing contractor.

The roof pitch is 0.05 degrees. Recommended minimum pitch: 3 degree.

The roof pitch is 0.05 degrees. Recommended minimum pitch: 3 degree. Recommend this be evaluated and reconstructed with correct pitch for better drainage.

Recommend this be evaluated and reconstructed with correct pitch for better drainage.

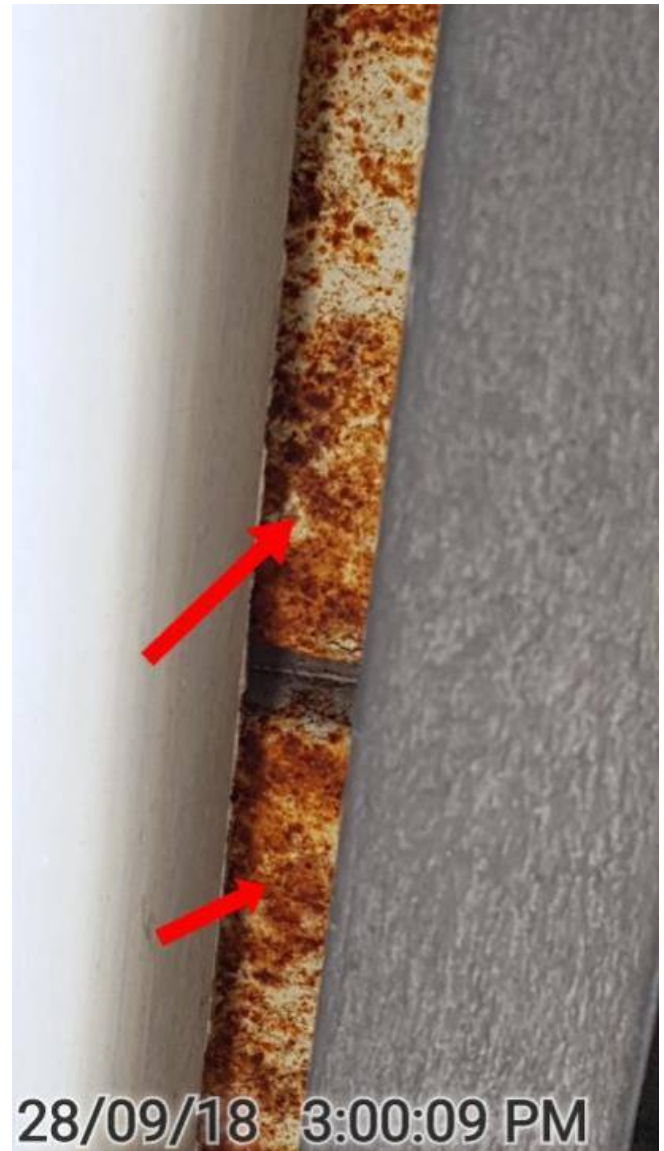
Rust noticed in some places needs repair.

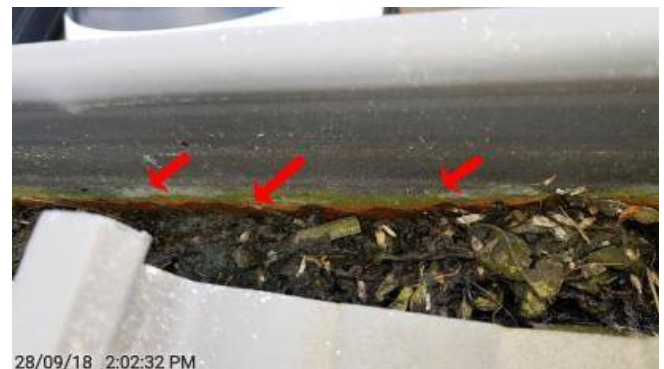
11.6 GUTTERS

Remove debris from gutter to allow proper roof run-off. Recommend installing screens over gutters to prevent further accumulation of debris.

Rust noticed in the gutter. Recommend this be repaired / replaced by a qualified roofing contractor.

Material, Metal - External,
Debris visible in the gutters at the time of the inspection.
Remove debris from gutter to allow proper roof run-off. Recommend installing screens over gutters to prevent further accumulation of debris.

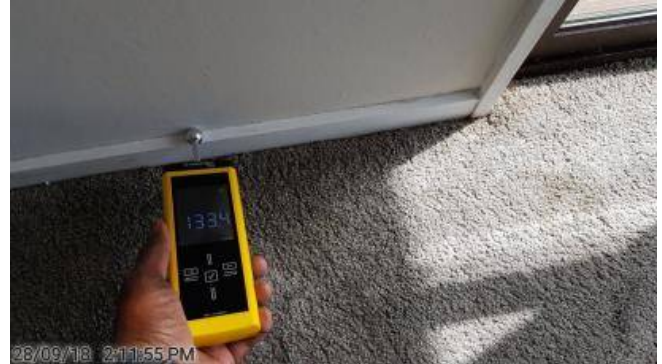
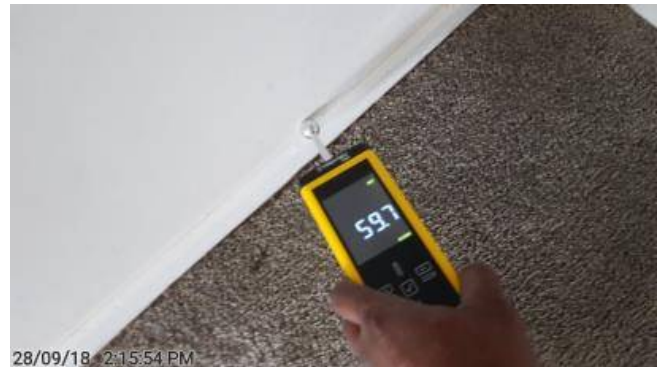
12.2 LIVING ROOM

High Moisture Readings were observed at the wall left of the sliding door. Recommend this be further evaluated using invasive / destructive inspection techniques by a qualified weather tightness surveyor.

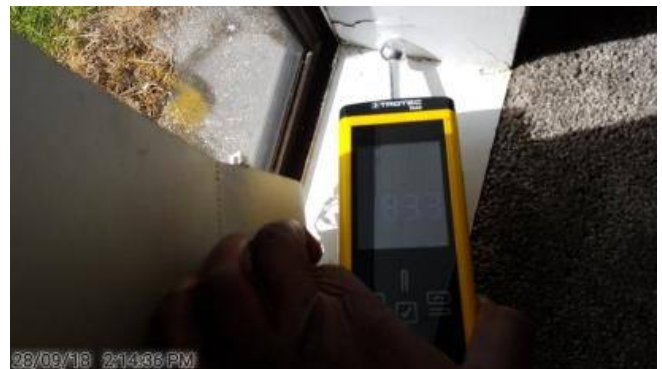
Paint peeling noticed in window frames. Recommend this be repaired and painted.

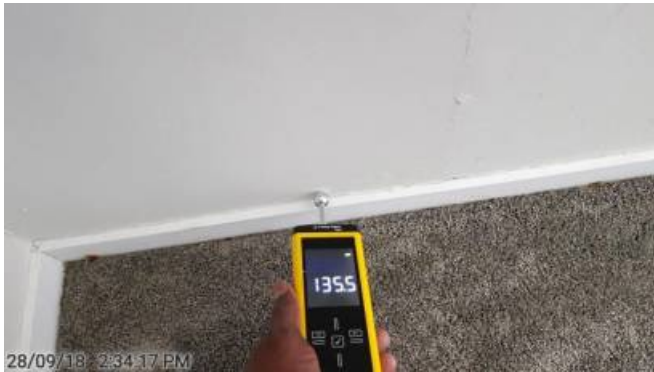
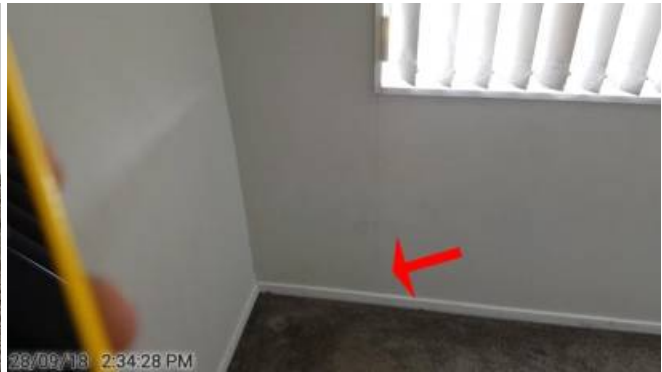
12.3 BEDROOM 1

High Moisture Readings were observed at the wall close to skirting below the window. Recommend this be further evaluated using invasive / destructive inspection techniques by a qualified weather tightness surveyor.

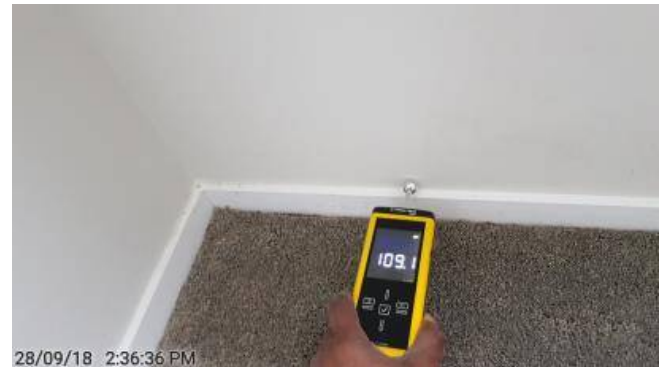
12.4 BEDROOM 2

High moisture readings were observed at the wall close to skirting below the window. Recommend this be further evaluated using invasive / destructive inspection techniques by a qualified weather tightness surveyor.
