Residential Inspection Report To NZS4306

Prepared exclusively for:
Mr Customer

XYZ St, Auckland

Prepared by:
Right Home NZ Limited
76B Rathmar Drive, The Gardens , Auckland,
0800 2R8HOME support@righthomenz.co.nz

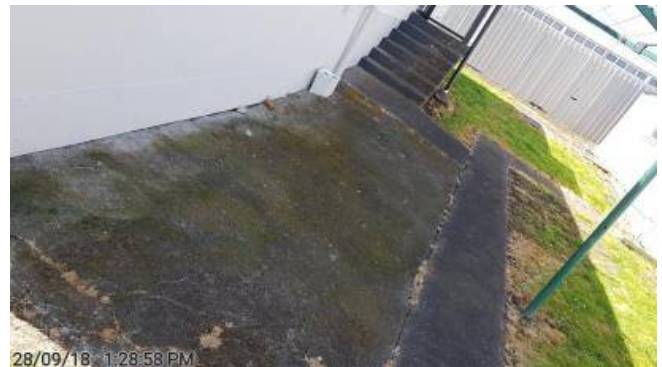
2.4 SURFACE WATER CONTROL

The ground is sloping towards the house (negative drainage) at rear. The ground should slope away from the home foundation. Excessive moisture content in soil supporting the foundation can compromise foundation integrity.

The Inspector recommends re-grading these areas to improve drainage near the foundation.

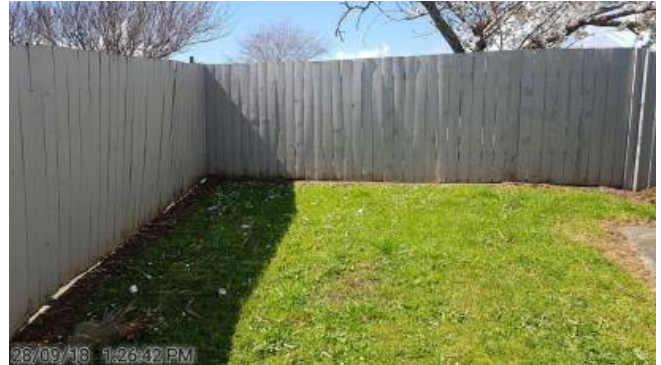
2.5 FENCE

Fencing is leaning at left side. Recommend this be repaired by a qualified fencing contractor.

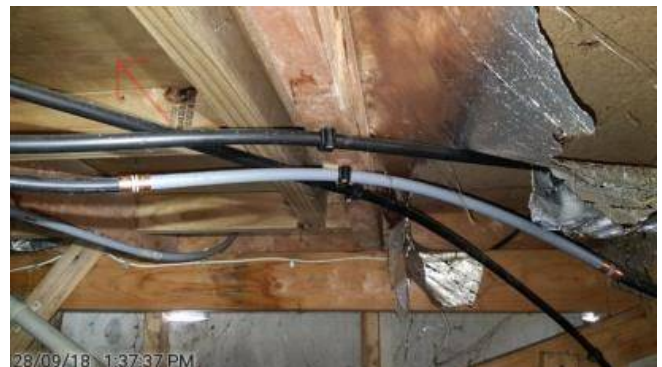
Floor sheathing below the bathroom area appeared to be replaced with plywood.

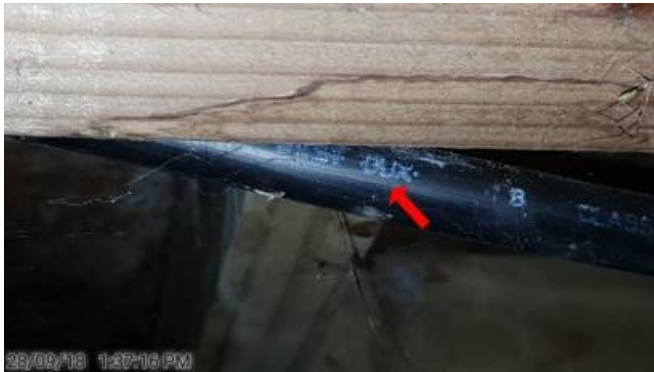
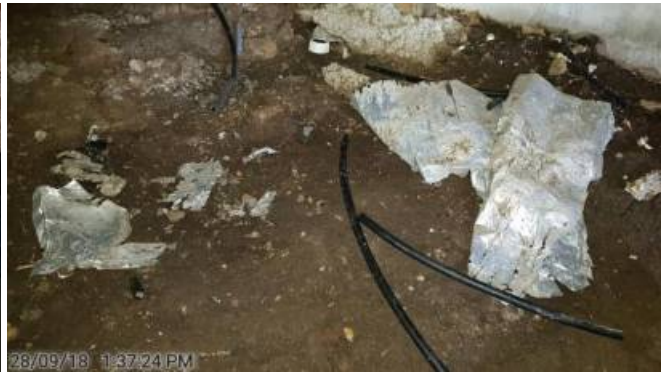
3.18 WATER SUPPLY PIPES

Black plastic piping found in the subfloor. This type of black plastic pipe has known history of causing water leaks at joints. In some places it has been replaced which appear to be done as a result of leak. Recommend this be evaluated by a registered plumber.

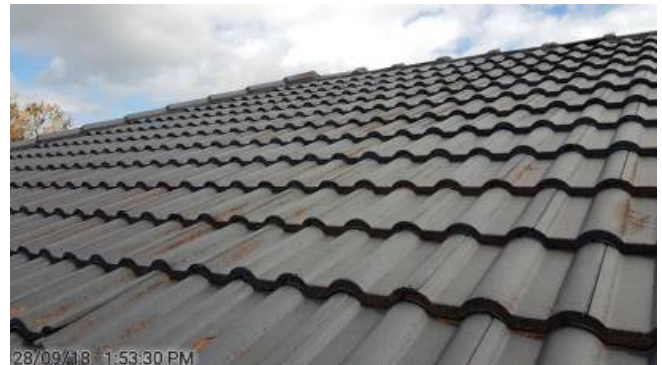
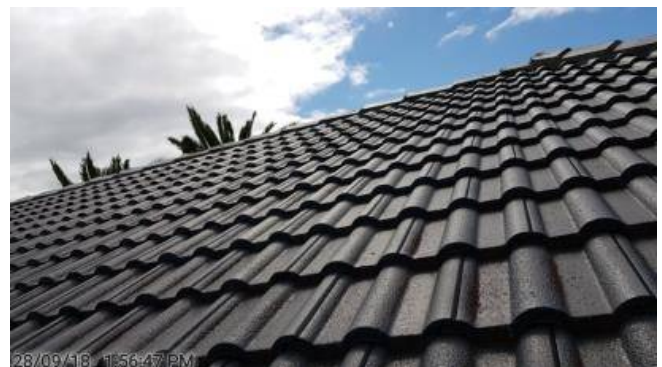
5.3 CONCRETE TILES

Mortar missing on some ridge tiles. Recommend this be repaired to prevent damage to the underlying roof structure from moisture intrusion.

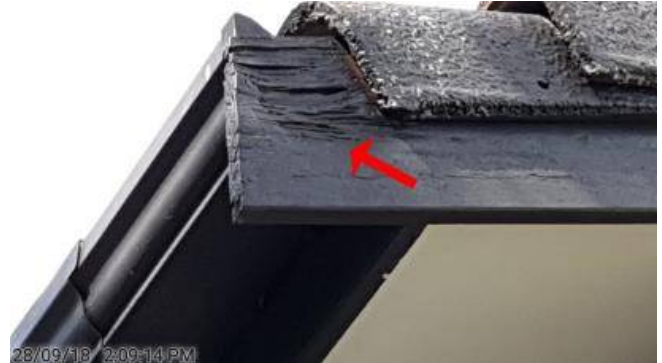
5.5 FASCIA / SOFFITS

Barge board at front appeared to be water damaged at the left end and needs to be repaired by a roofing contractor.

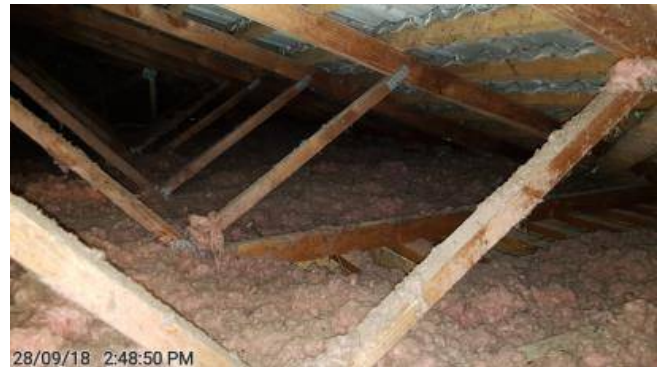
6.6 CEILING CONSTRUCTION

Overview.

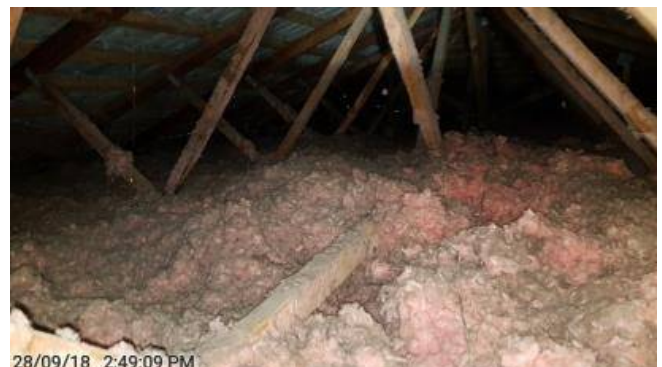
6.10 INSULATION CONDITION

Insulation thickness is approximately 100 mm.

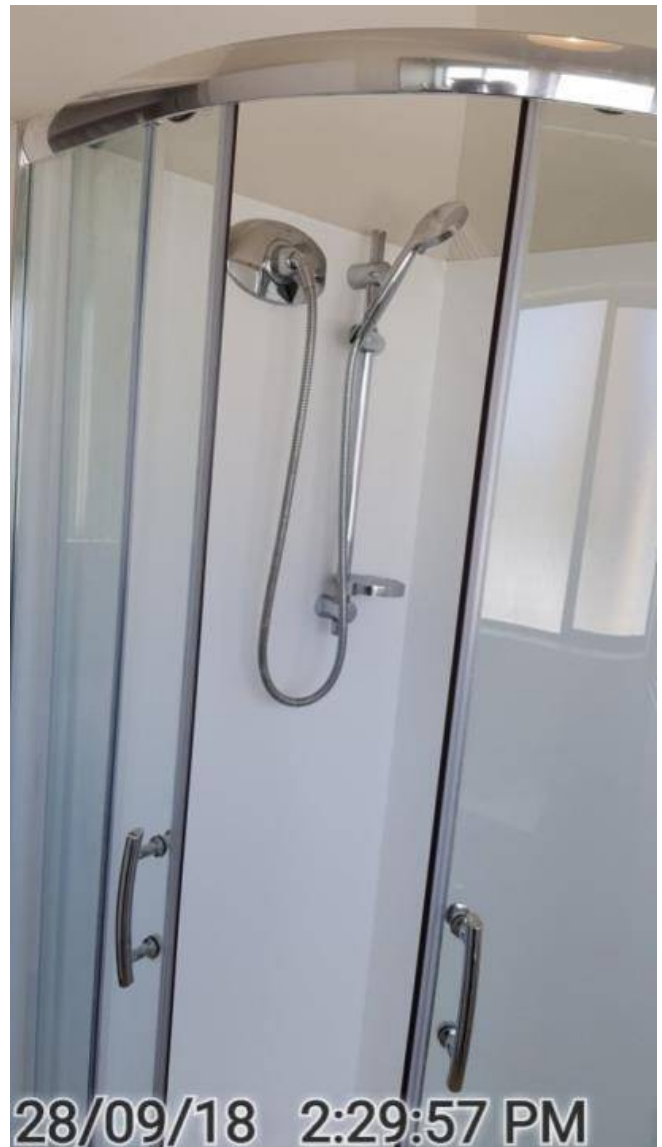
8.11 SHOWER ENCLOSURE

Material, Plastic lined
Screen, Glass,
The shower had functional water flow and drainage at the time of inspection. No visible leaks at the time of inspection.

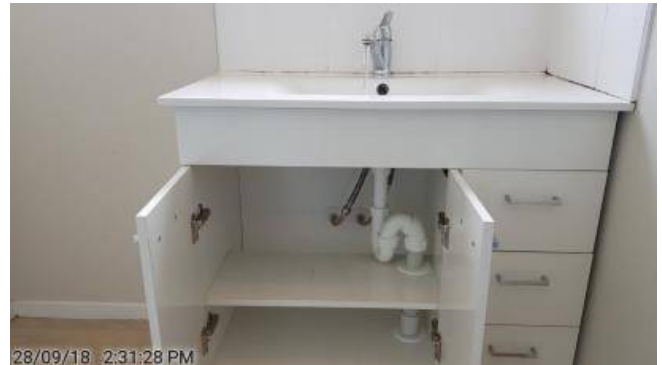
8.12 VANITY / SINK

Material, Ceramic bowl in a melamine cabinet,
The sink appeared to have functional water flow and
drainage at the time of the inspection. No visible
leaks with sink plumbing.

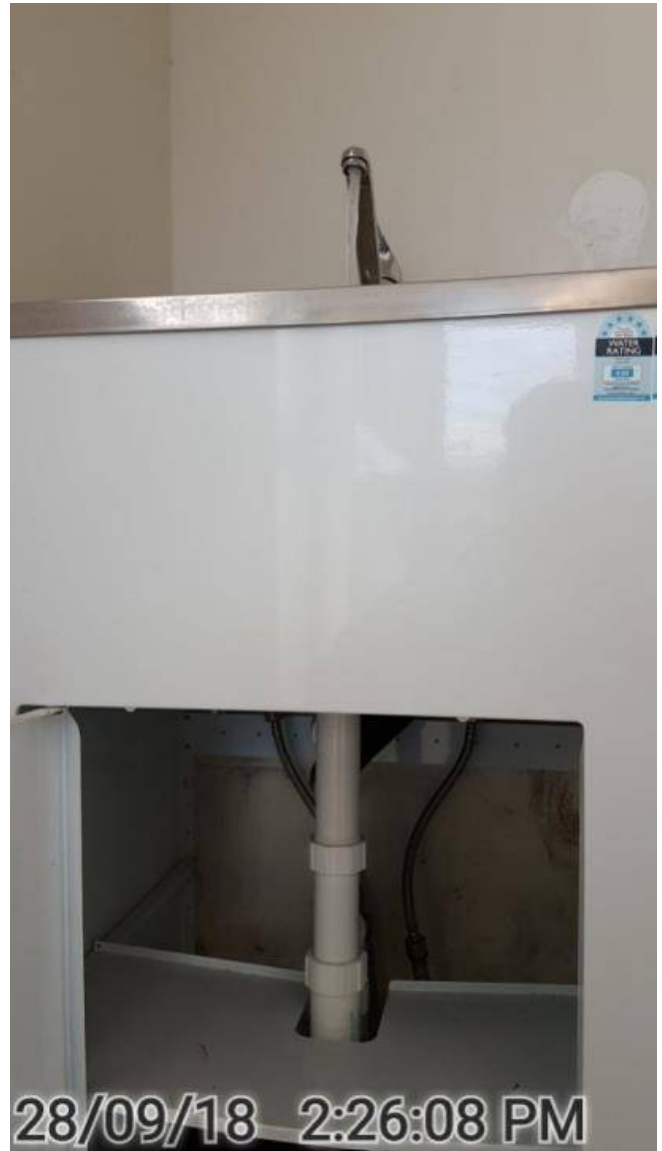
8.20 SINKS

The sink appeared to have functional water flow and drainage at the time of the inspection. No visible leaks with sink plumbing.

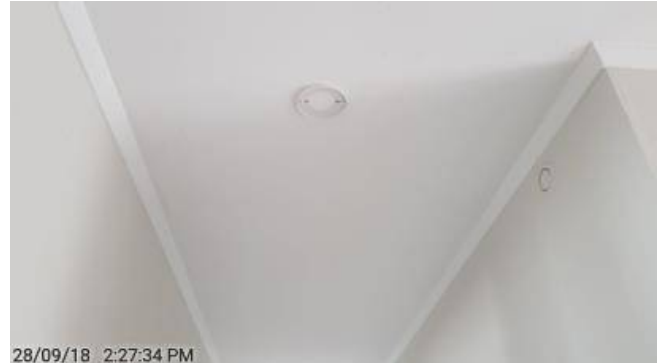
8.31 SMOKE DETECTORS

No smoke detector observed on this floor.
The Inspector recommends installing smoke detectors in compliance with modern requirements.

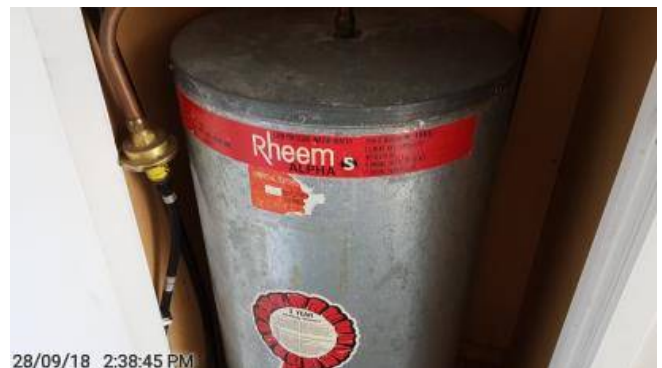
9.3 Make:

System is Rheem.
Year Of Manufacture : 1987.

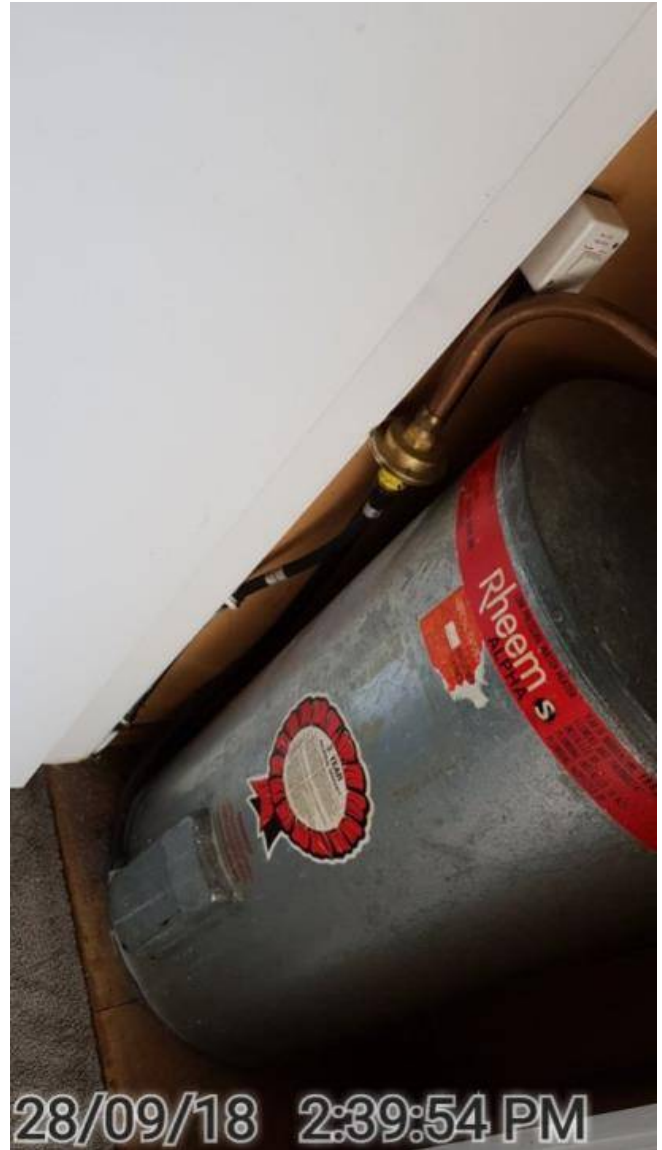
9.7 Electrical Service to Water Heater:

The electrical service to the water heater appears to be installed in an acceptable manner.

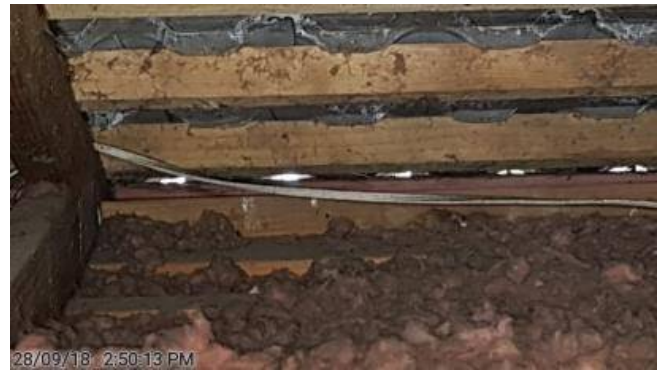
10.5 ELECTRICAL (Attic)

TPS (Thermo Plastic Sheathed) cabling observed.
This is a type of electrical cabling currently used.

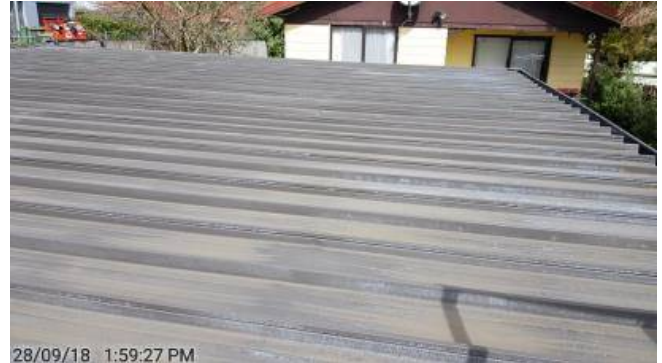
Rust damage with holes on the roof sheet noticed which can cause roof leaks. Recommend this be repaired by a qualified roofing contractor.

The roof pitch is 0.05 degrees. Recommended minimum pitch: 3 degree. Recommend this be evaluated and reconstructed with correct pitch for better drainage.

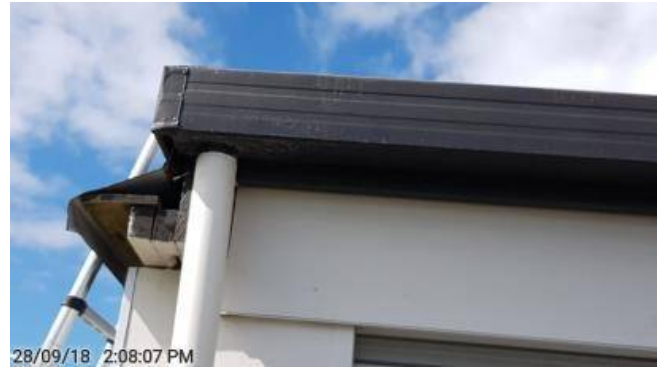
Material, Metal - External,
Debris visible in the gutters at the time of the inspection.
Remove debris from gutter to allow proper roof run-off. Recommend installing screens over gutters to prevent further accumulation of debris.

Rust noticed in the gutter. Recommend this be repaired / replaced by a qualified roofing contractor.
